**ROOFING - AN INVESTIGATION, AND RECOMMENDATIONS  
FOR IMPROVING PERFORMANCE ON  
ALBERTA GOVERNMENT BUILDINGS**

Department of Public Works  
Government of the Province of Alberta  
August, 1967.

RE: Roofing

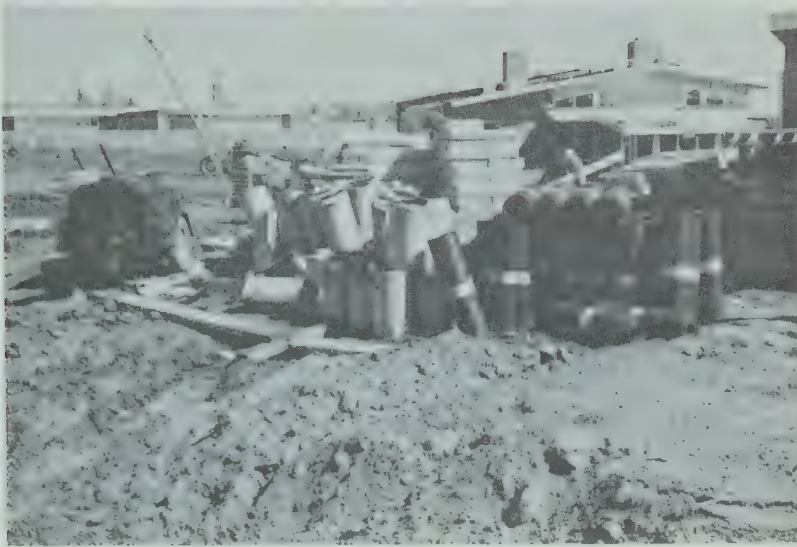
1. Improper storage of materials. Felt rolls should not be stored flat. Note rolls stacked in the mud. This type of storage promotes fishmouthing and excess moisture content.

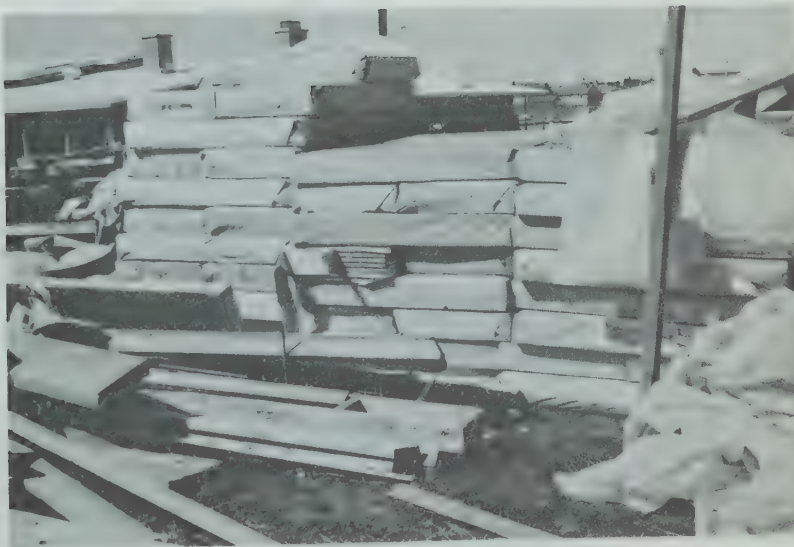
2. Unprotected insulation - bundle wrappings broken-no pallet to keep material out of the mud, and no protective covering over stacks.

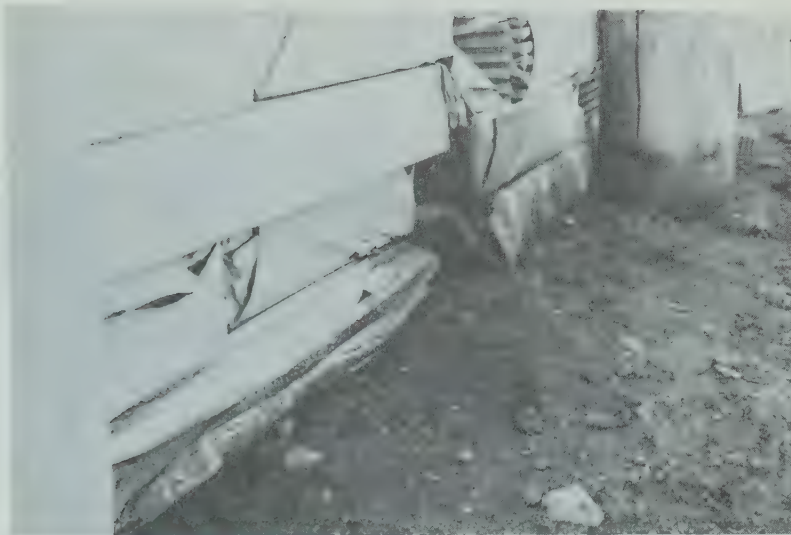
3. Unprotected insulation.

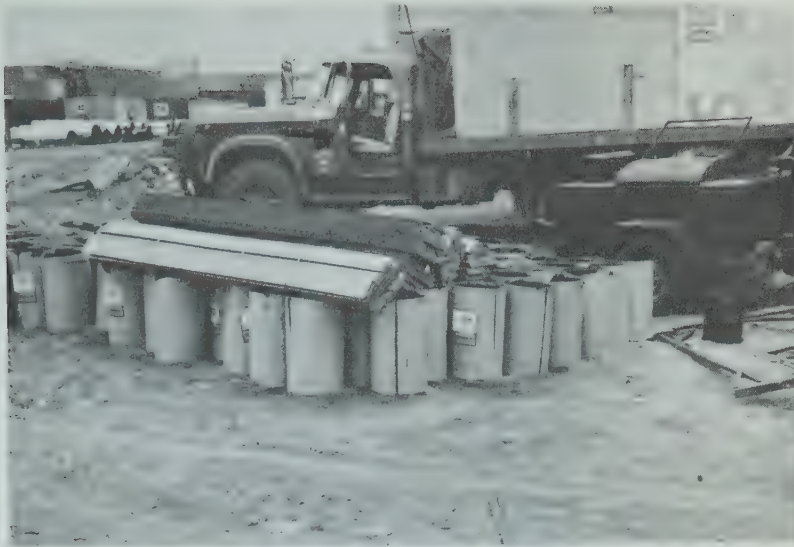
4. Unprotected wood fibre cant strips.

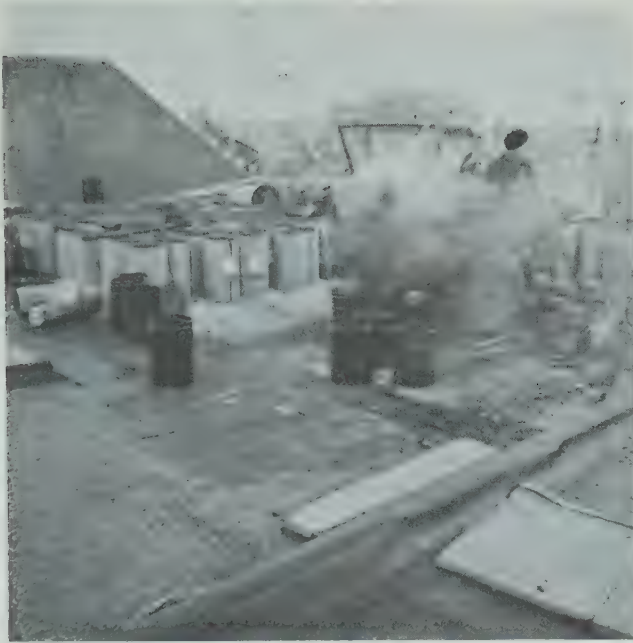
8. Trafficway for entire roofing operation - insulation and felts badly damaged.

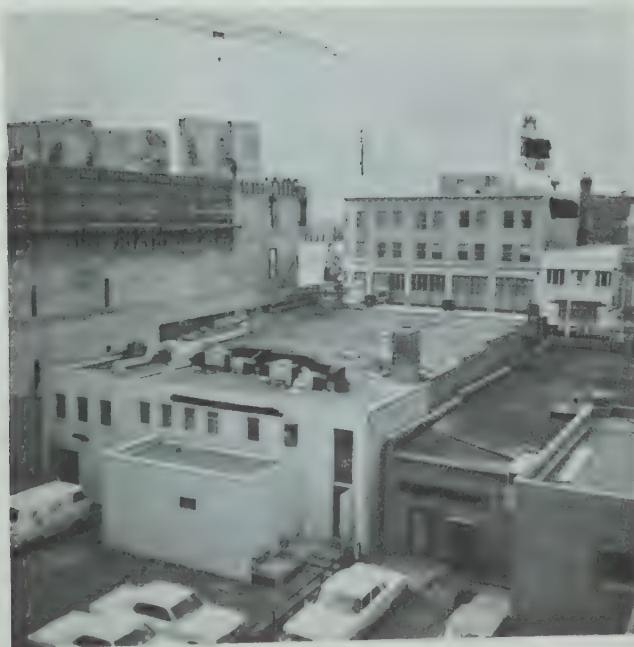
9. The low roof will probably be damaged during construction of adjoining high building.

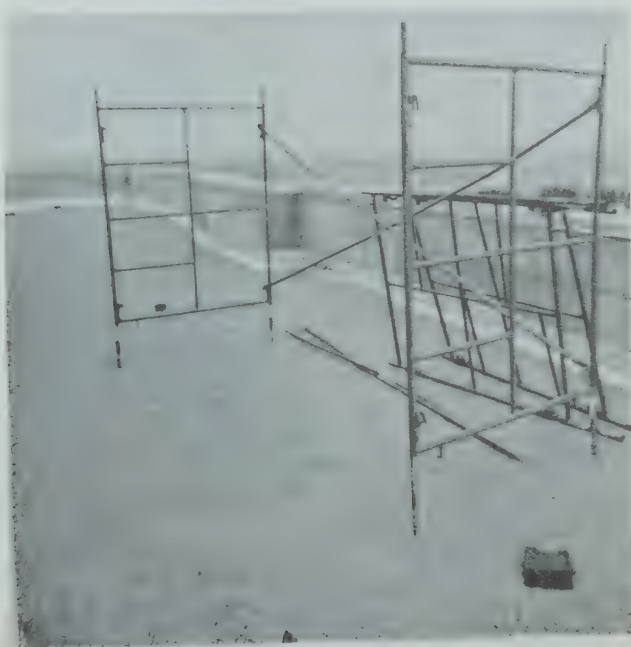
17. Mechanical damage to completed membrane.

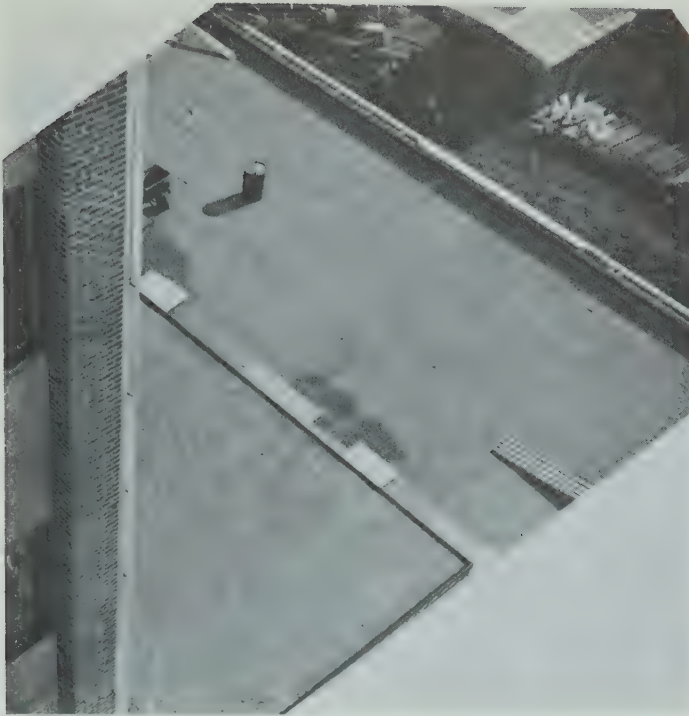
18. Probable mechanical damage to completed membrane.

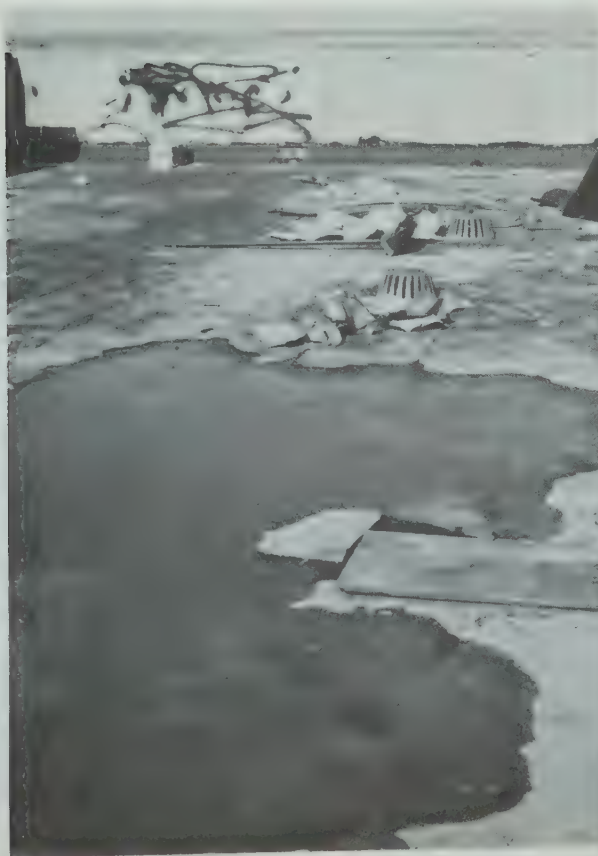
19. Water soaking into unprotected rag felts.

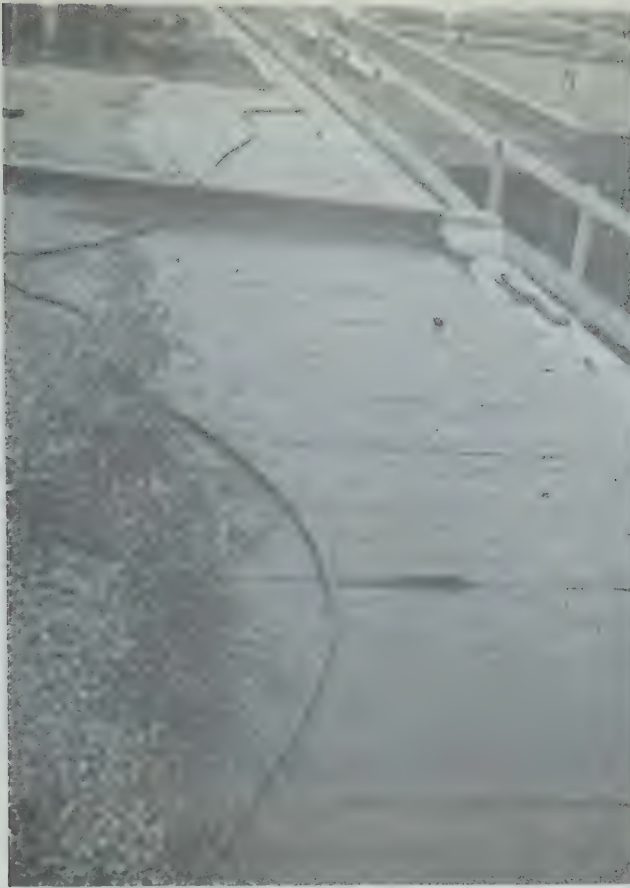
26. Severe fishmouth - unprotected felts. On some types of insulation, the loose stones will penetrate the membrane if stepped on.

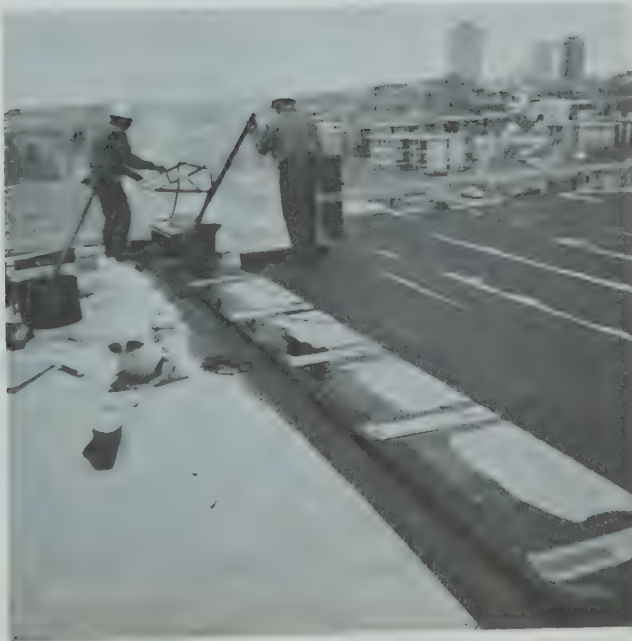
31. Installation of cut-off - The resulting rounded edge may well cause more problems than the cut-off is intended to eliminate.

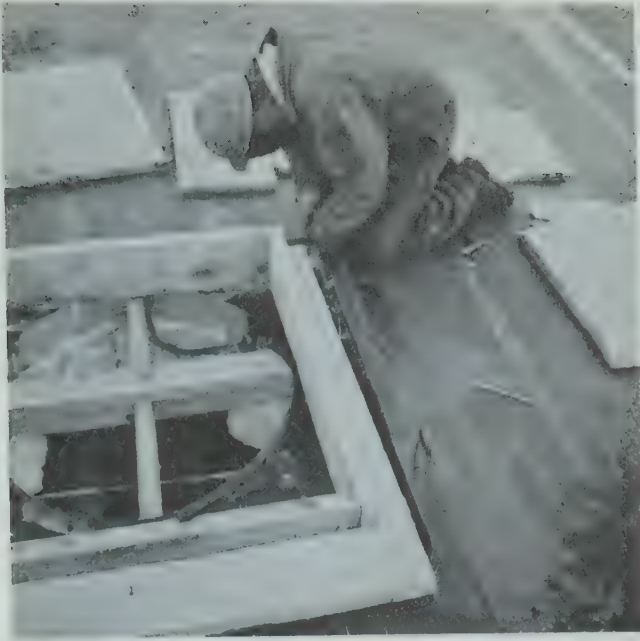
32. Installation procedure precludes installation of edge cut-off. Edge cut-offs are a must.

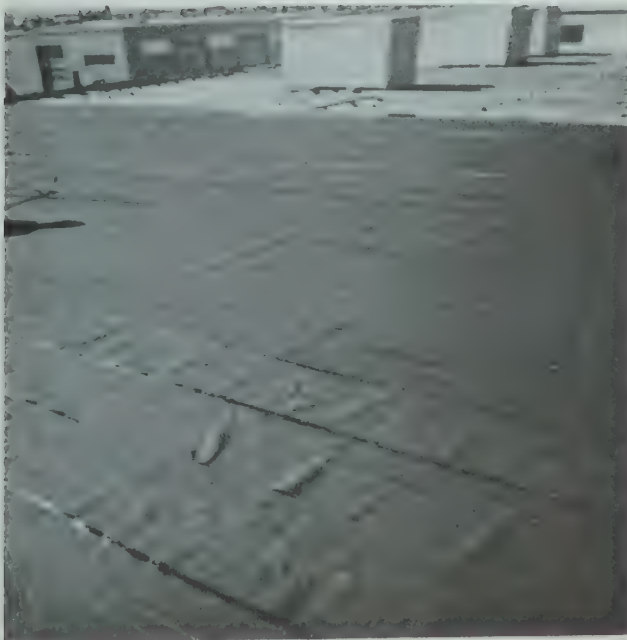
35. Severe fishmouthing resulting from poor felt rolls - a 2 + 2 application will reduce appreciably the possible failure of this area.

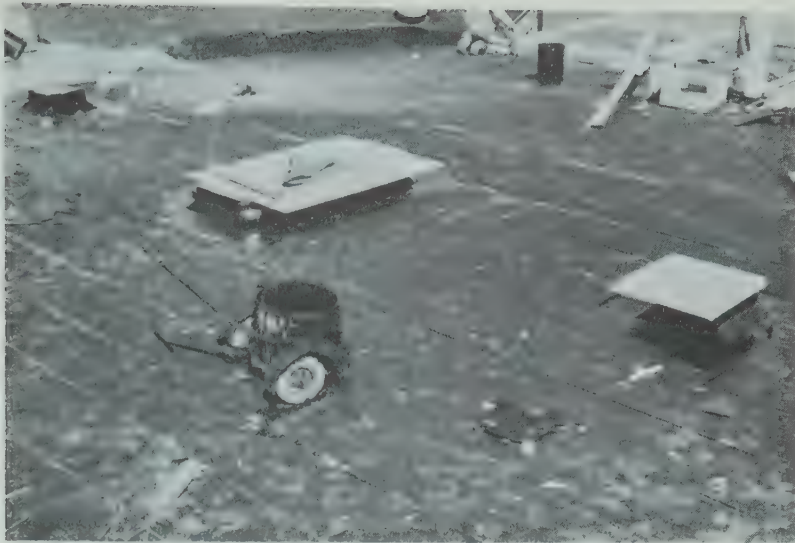
51. One 2 x 4 dropped, and the roof leaks!

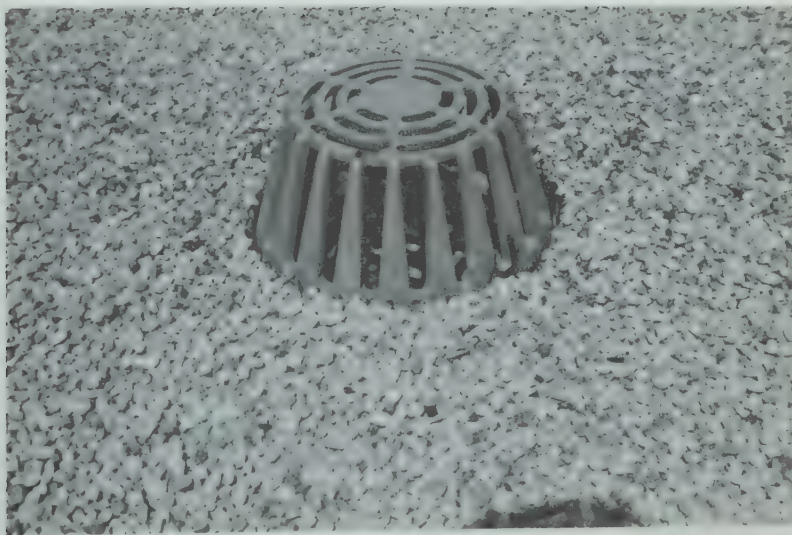
52. Roof drain - screen does not prevent gravel from being washed into drain, resulting in possible plugged line.

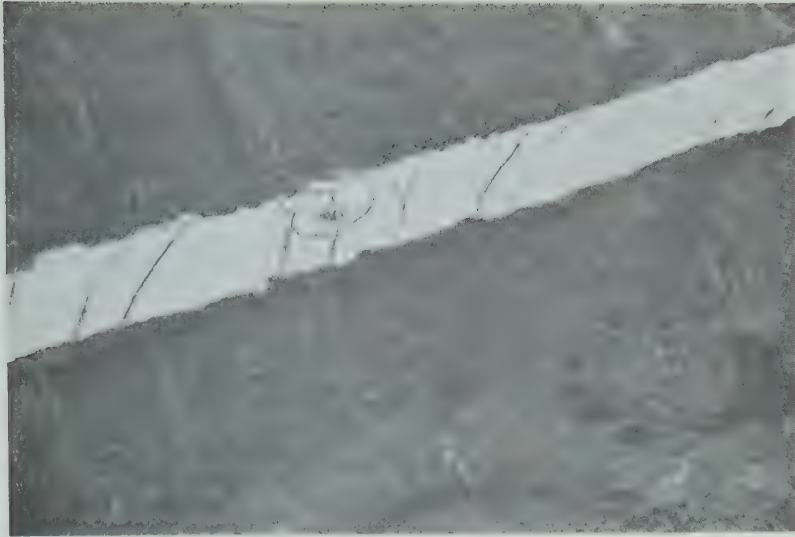
53. Most paints crack when exposed to sunlight. The crack in a 2 mil film of paint is a sufficient stress raiser to cause a deep fissure in the asphalt, as happened in this test.

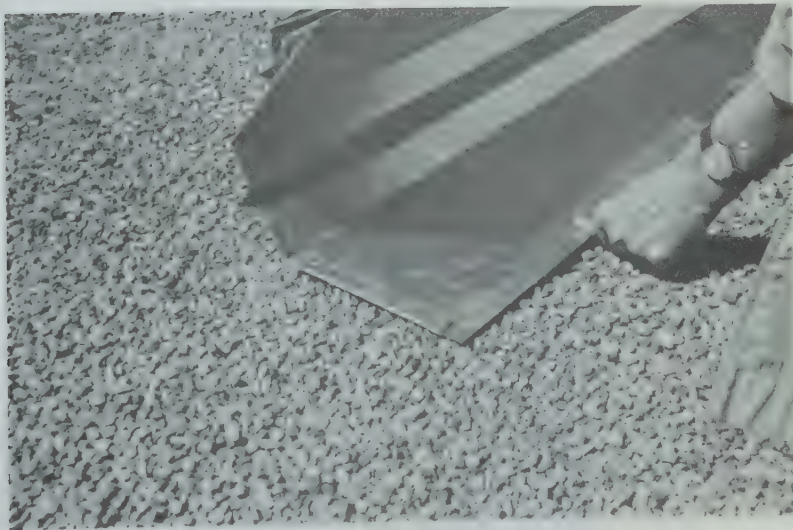
54. Flashing joint - Good and bad details - double "S" bend in 26 ga. galvanized iron is good. This joint should be improved by the extension of the upper face of the bend to allow proper anchorage. The length of the bend should be at least 2". No provision for continuity of lower edge.

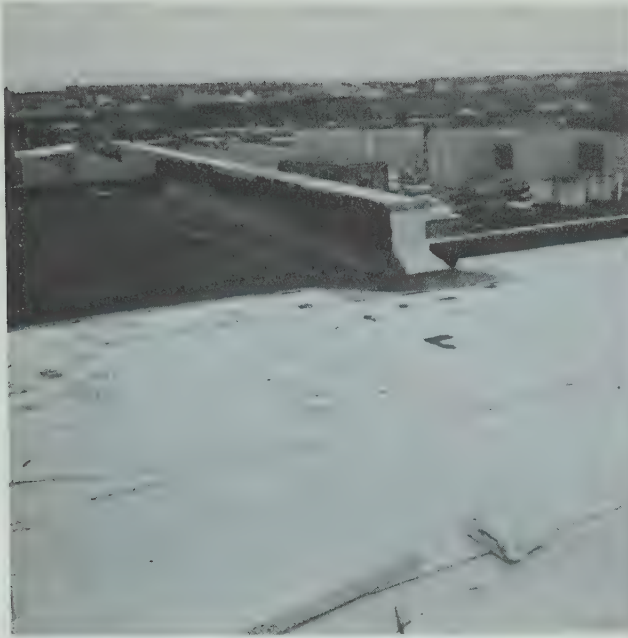
68. Felt run up parapet, Loose fit to cant strip and parapet contour is source of trouble in completed roof.

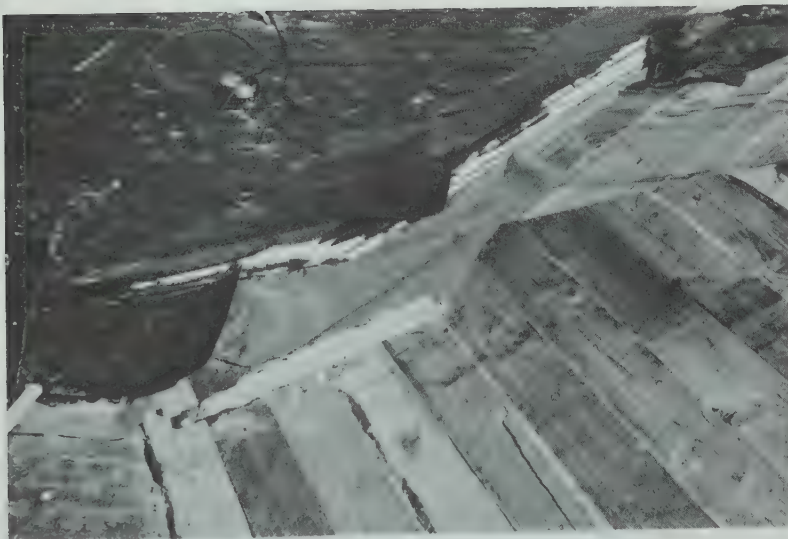
69. Loose fit of insulation at change in roof contour. Photo shows wood deck, single x waxed kraft, 2" wood fibreboard and 4 ply 15# rag felt.

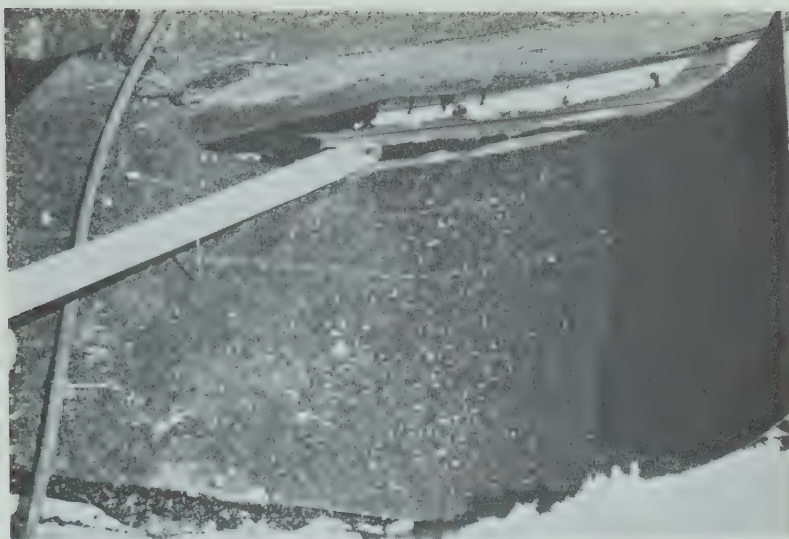
70. Close-up of above photo, showing  $\frac{3}{4}$ " gap between insulation and deck. Gap is about 10" wide.

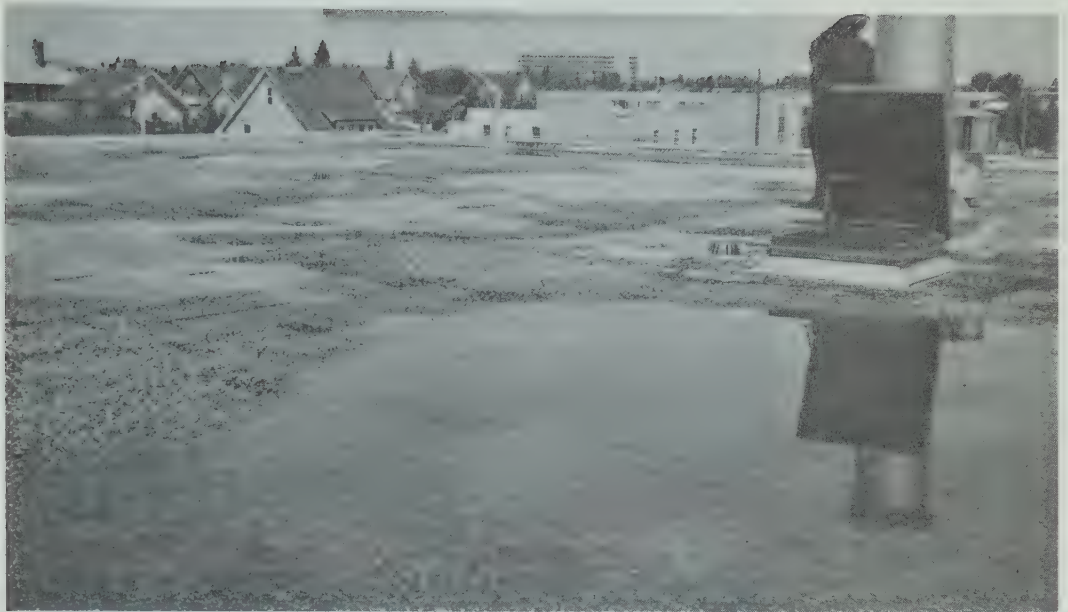
89. Roof membrane suffering from extensive blistering. This roof membrane has been rising and falling for some years now, but as yet has not leaked. It won't belong, however - the gravel has been blown from the tops of the blisters, and the glass fibres in the felts are becoming exposed. Note the water, and location of drains.

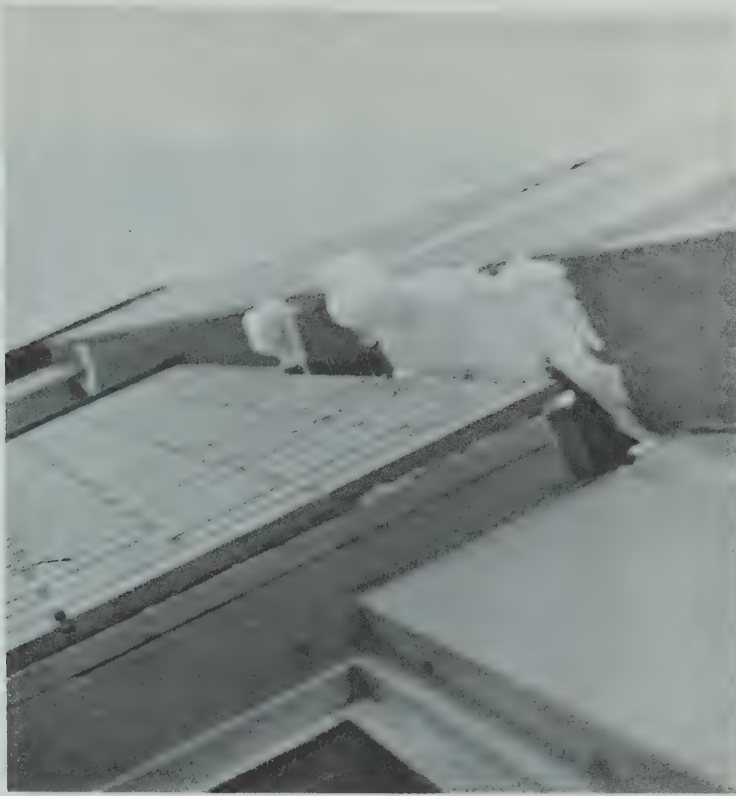
91. Photo taken looking up wall of Foothills Hospital - a visual reminder that this same ice buildup, resulting from moist air escaping onto a cold surface, can occur under a roof membrane, and cause delamination and rupture . (Dec. 1966 - outdoor temperature -  $5^{\circ}$  F.). This escape of air is more pronounced in tall buildings due to stack effects.

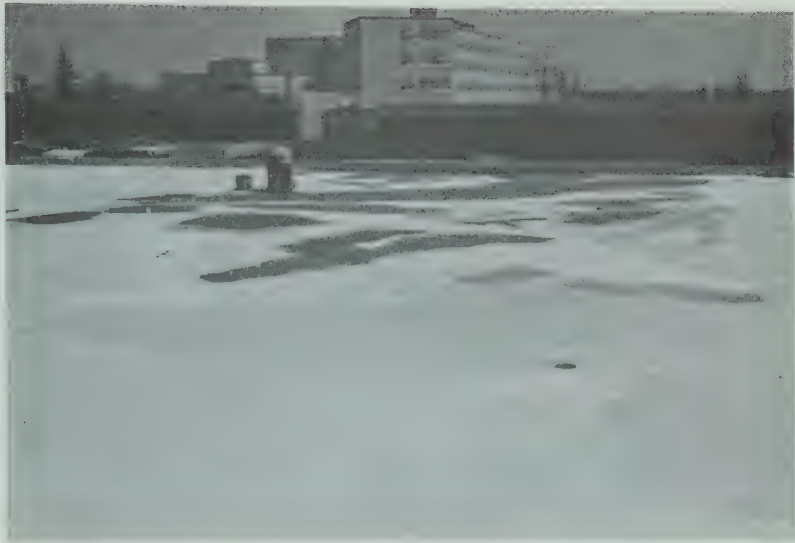
94. Patching of spalled areas of Zonolite insulation. Spalling was result of light frost after placing.

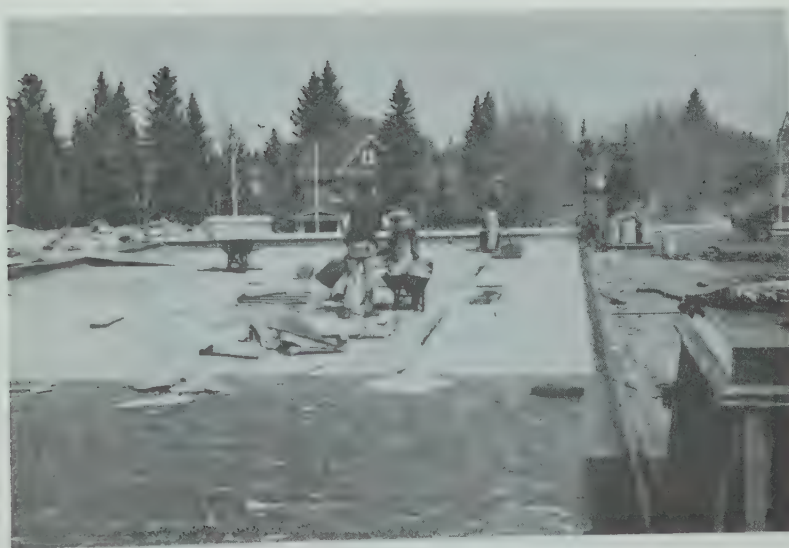
107. Replacement of wood fibreboard insulation - approximately 250 squares were replaced at a cost of about \$20,000, according to the contractor. This replacement was necessitated by mechanical damage to membrane which occurred during construction of the building.

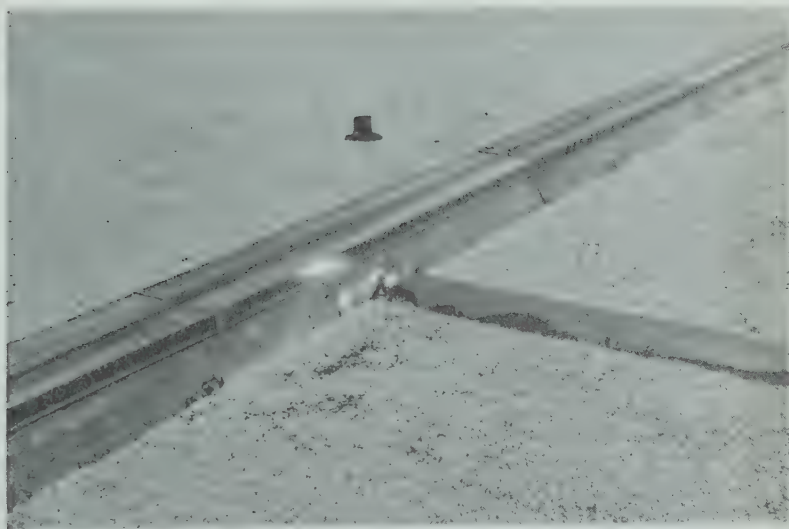
111. Flashings over control joints after reroofing completed. Flashing to the right does not project high enough above roof surface. Wind-whipped water will find a leak if there is a weak spot.

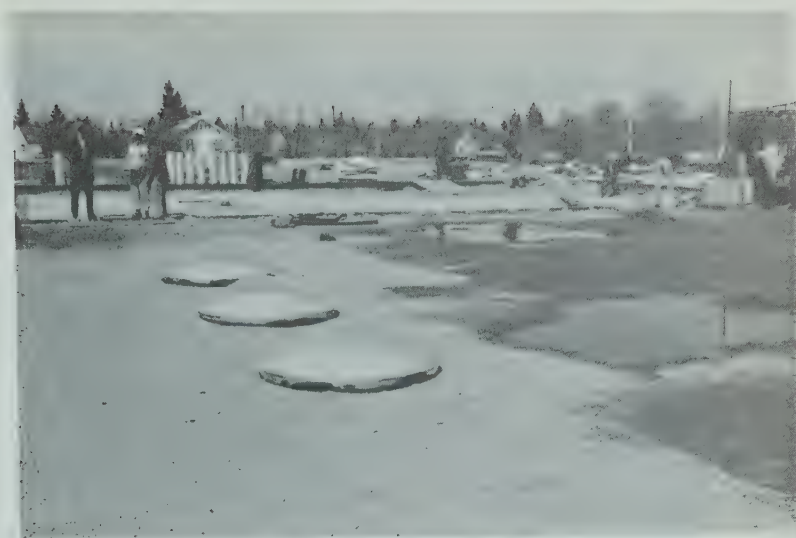
112. No slope to drain on this roof. Ponded water will cause accelerated deterioration of asphalt. In spring and fall, (also in winter, if insulation has lost the most of its insulating value) alternate freezing and thawing of water may damage a membrane severely by accelerating splits.

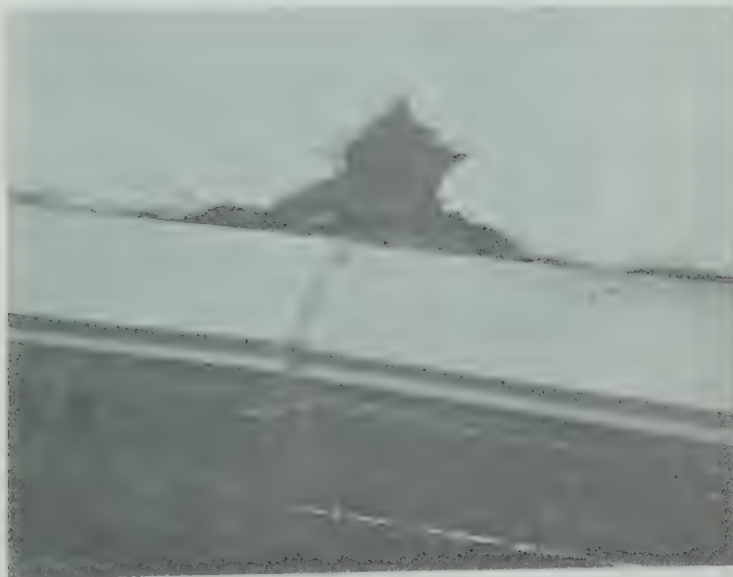
120. Graphic illustration of escape of warm air from building interior. Note exterior caulking has become brittle and cracked.

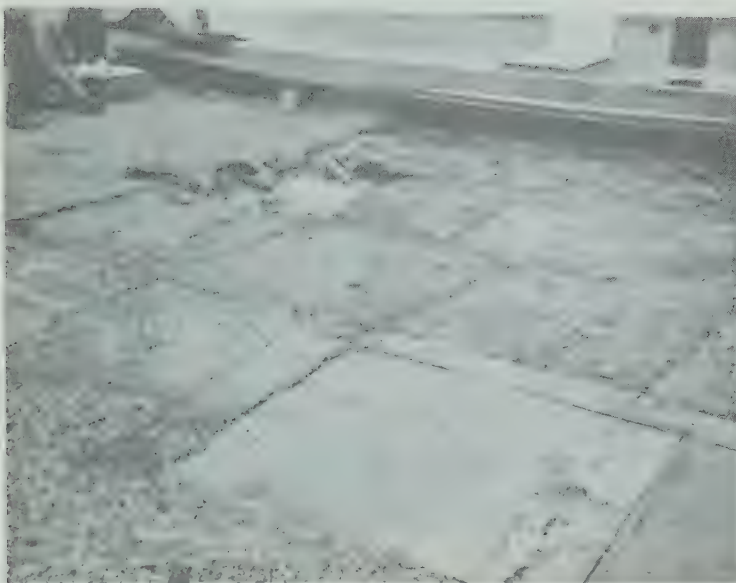
121. Removal of completely saturated Stramit - a very messy job. March 28th, 1967 - "C" Block.

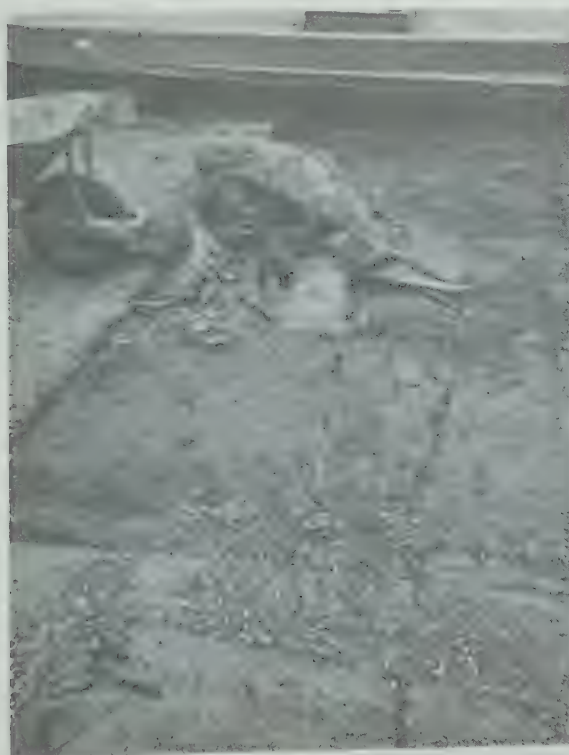
122. Removal of soaked Stramit - note water standing on the deck. Needless to say, water was running through the ceiling below. The water leaked into the insulation through faulty flashings. No splits or holes were found in the membrane.

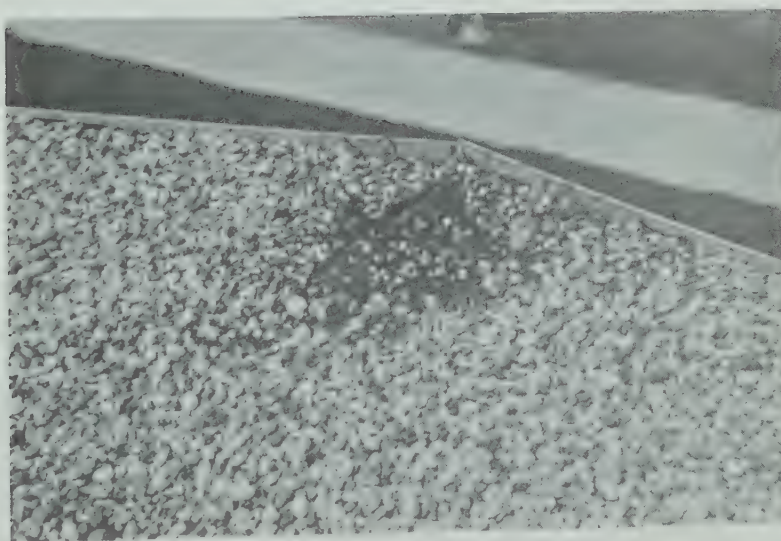
126. Poor gravel stop installation - end of metal strip was not properly contoured to the deck, and the sharp end has worked itself through the membrane. The resulting hole in the membrane resulted in a leak, and ruin of this area of the roof.

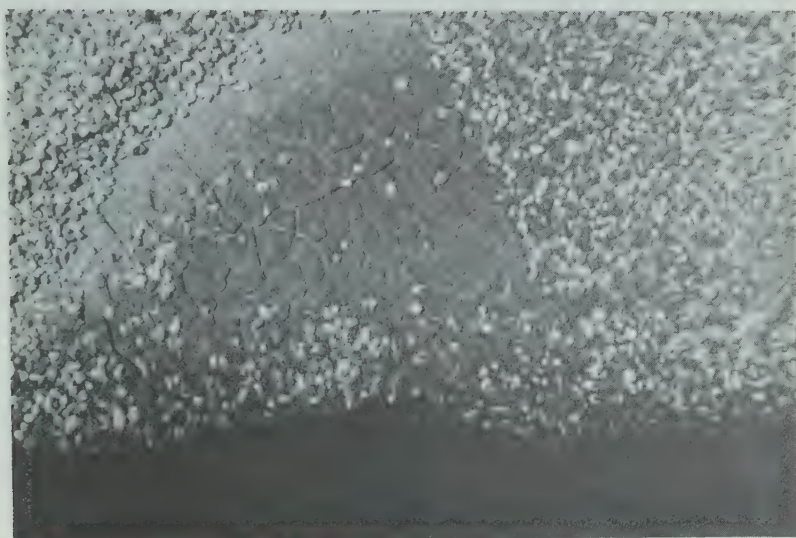
127. Lack of asphalt on the flood coat resulting in wind blowing away the gravel. Note the crazed asphalt - cracks penetrate to the glass fibres of the felts.

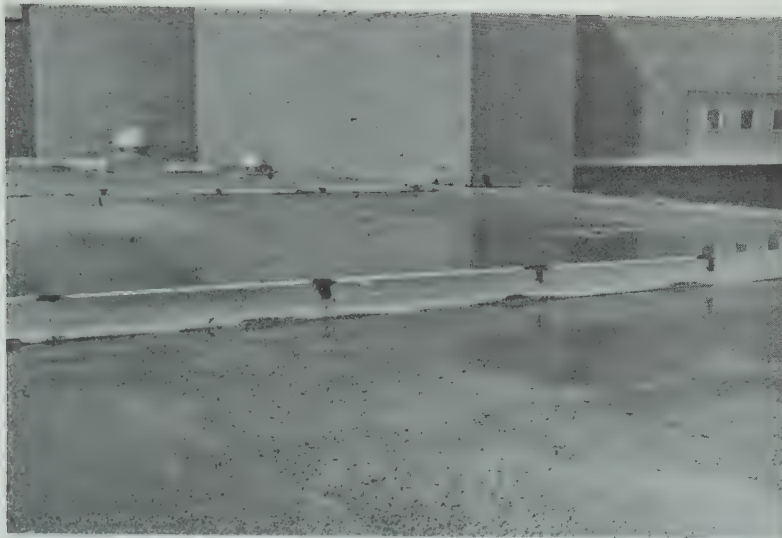
128. Reroofed and reflashed area (1966/67) - note caulked joints in flashing. Top of flashing is sloped to center, forming a trough to catch water. Already this caulking is peeling off of the metal. Note also the ponds of water, and roof drains high and dry.

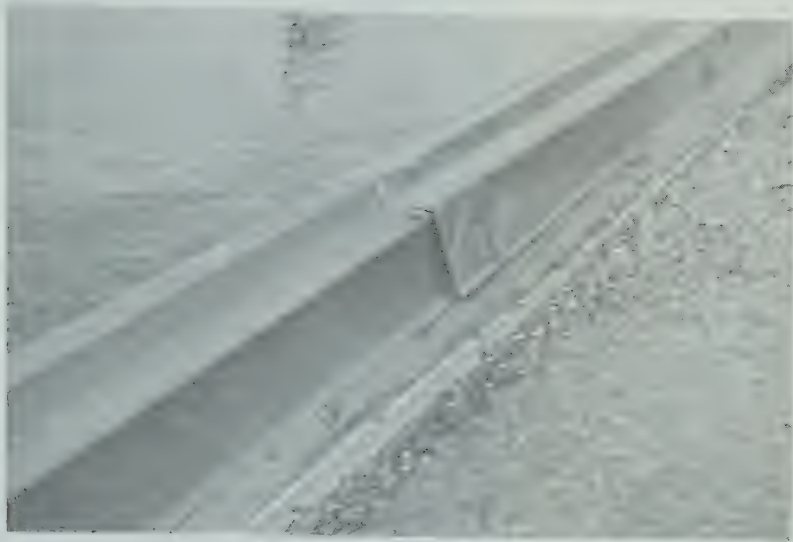
134. Flashing which was installed less than one year ago. Caulking has cracked. Note pond on far side of control joint. A leak here is imminent unless this is repaired. If it leaks, how much insulation will become soaked?

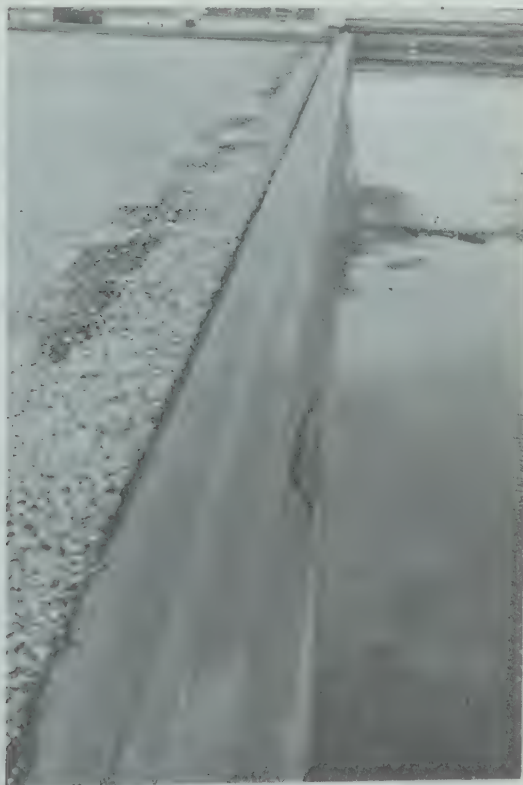
135. Roof membrane control joint - installed only last year during reroofing. There were no joints in this roof initially. Note the 8" difference in elevation between surfaces (drops left to right). The original detail here was simply a strip of 60# mineral coated selvege mopped onto the membrane felts.

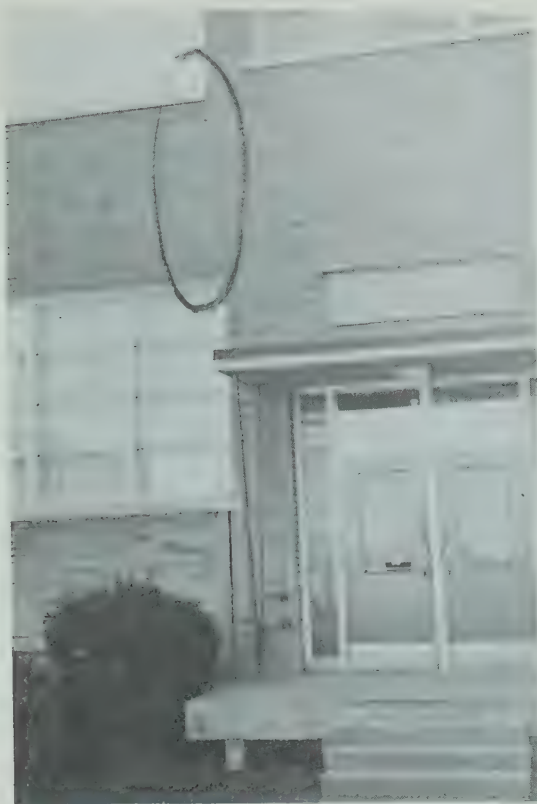
136. Control joint runs up through foundation, main floor slab and topping, plaster block and brick walls, but does not continue through the roof structure or parapet. The entire 900 ft. long by 60 foot wide roof structure is in one continuous piece. Note the joint in the brick above the window was overlooked - the brickwork formed its own joint, however.

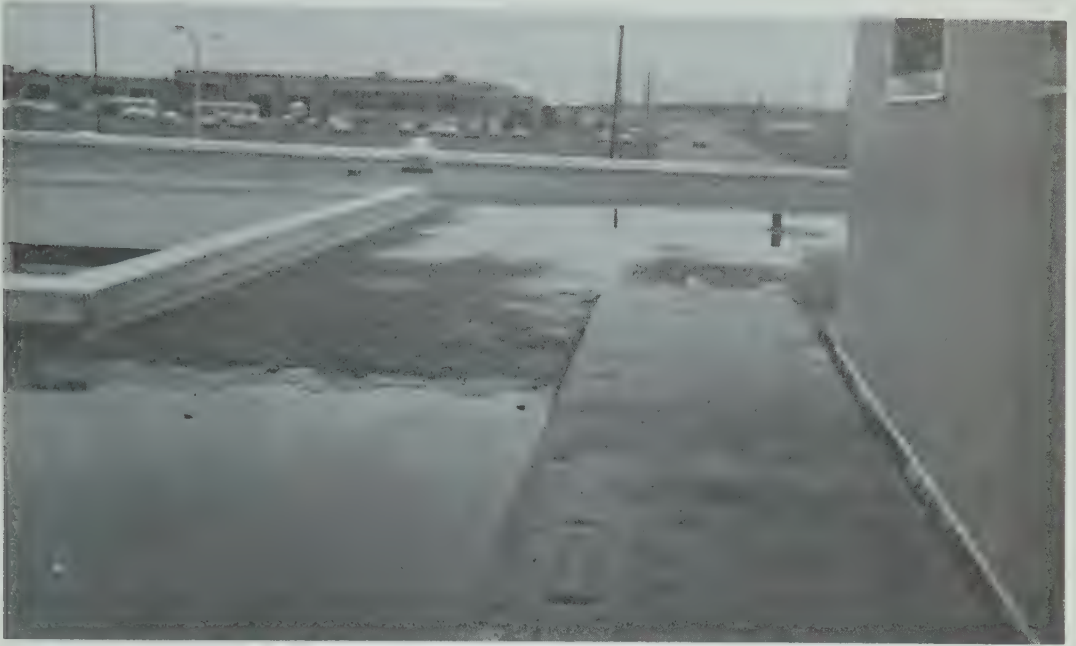
139. Phase I roof - note water standing remote from drain. The reflashing here illustrates proper depth of drip-leg.

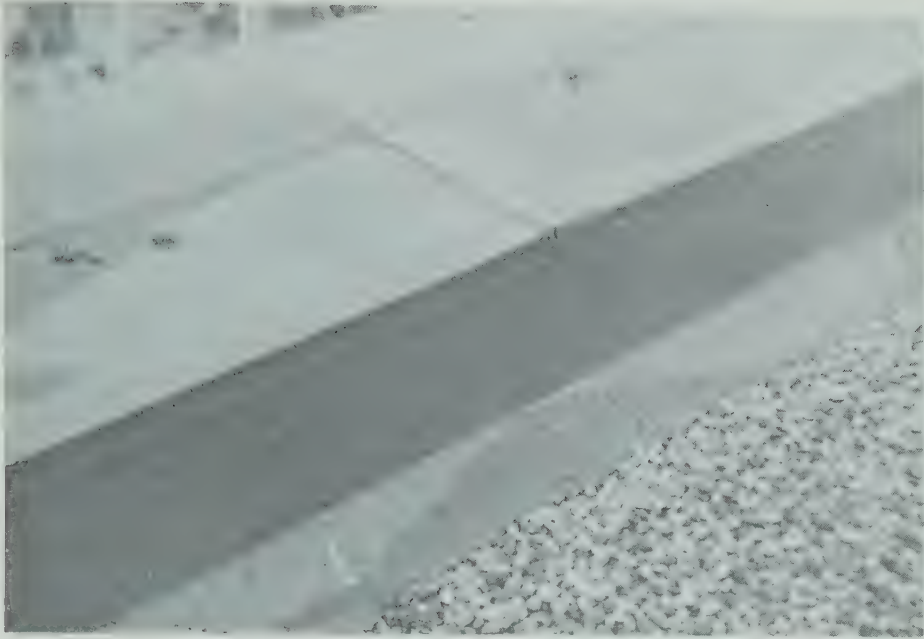
143. Phase III original copper flashing - note water lying against cracked caulking - drip leg of cap should be min.  $4\frac{1}{2}$ ", but is only just over 1".

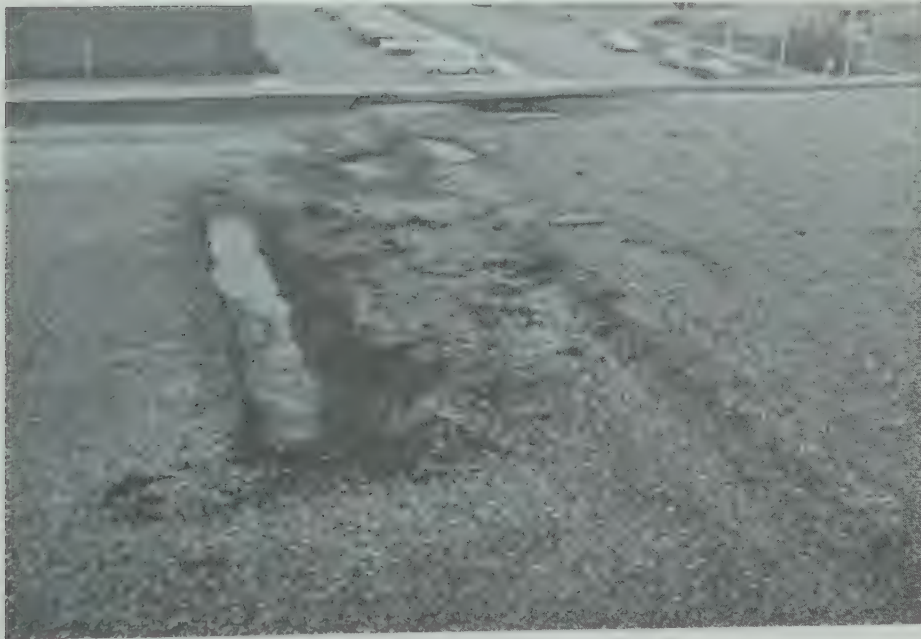
144. Phase III Medical Wing - 5" change in roof elevation should have had metal gravel stop and cant base flashing - repairs are in progress.

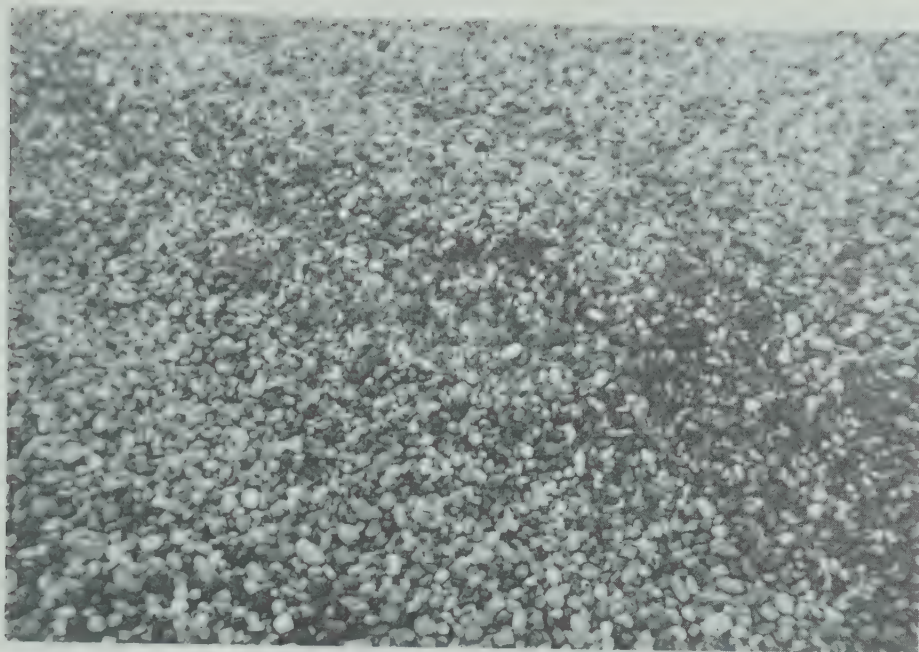
145. Phase III Medical Wing - the reason for the repairs. Note deep fissure in asphalt. This crack extends through the membrane. Picture is close-up of lower R.H. corner of photo #144.

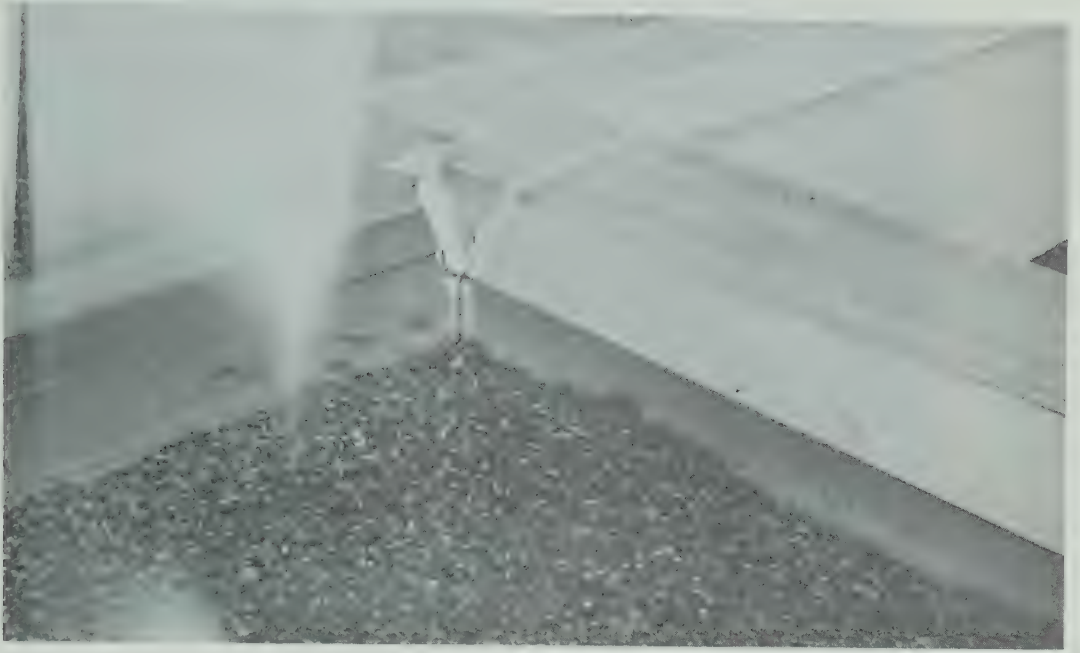
147. Phase I - mitered corner in flashing was originally soldered. The soldered joint broke apart, and now the caulking has ruptured.

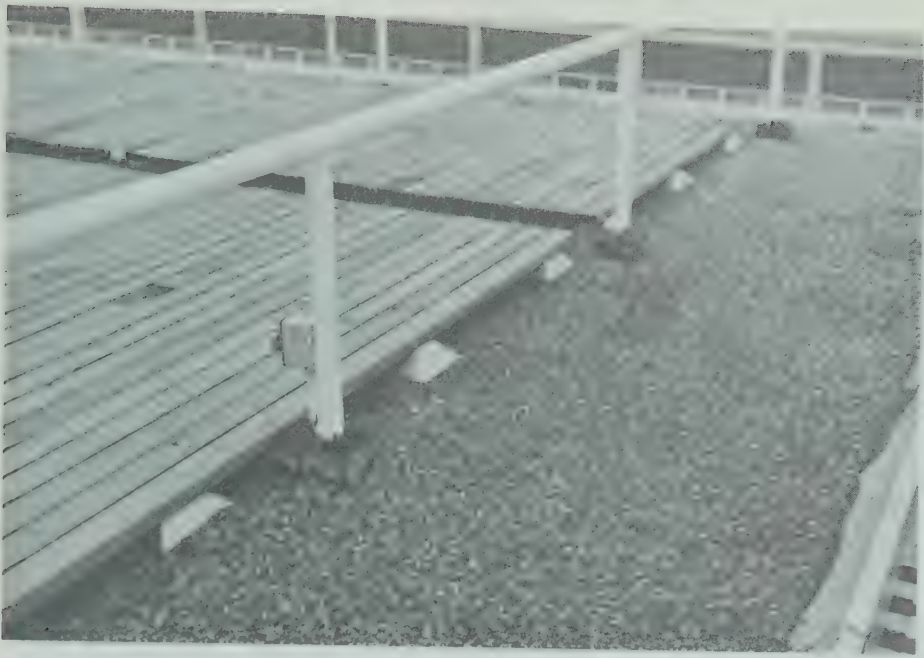
149. Newly installed bases for wooden platform (see fig. #19). Original platform rested on sleepers layed directly on membrane - leaks developed after membrane split.

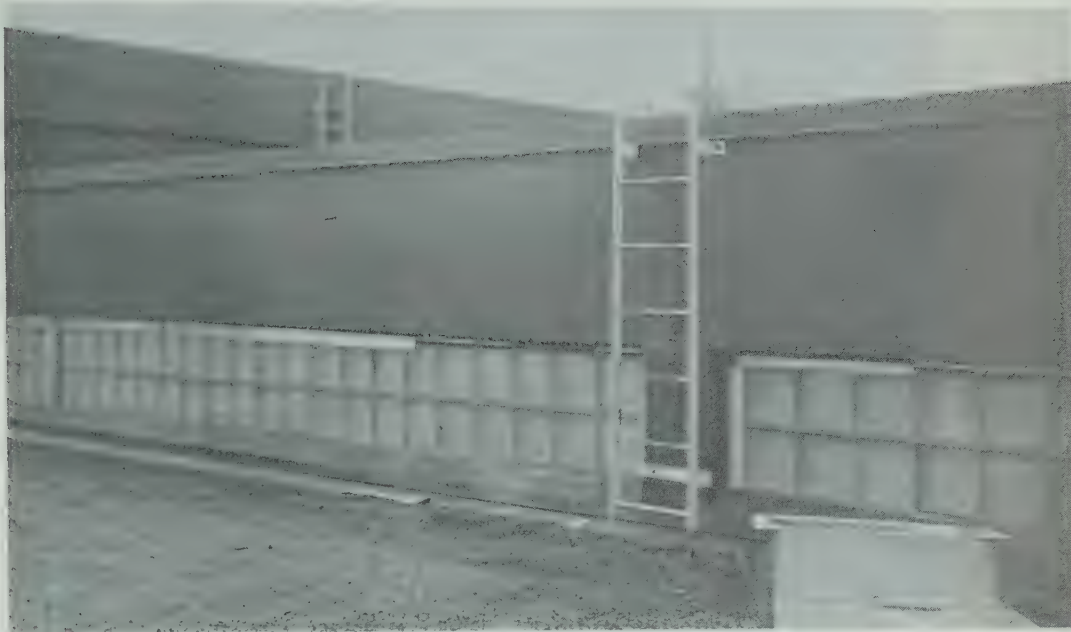
151. Reinstallation of cracked glass block has been completed. Flashings now are having to be introduced to prevent leakage. Original detail had no flashing.

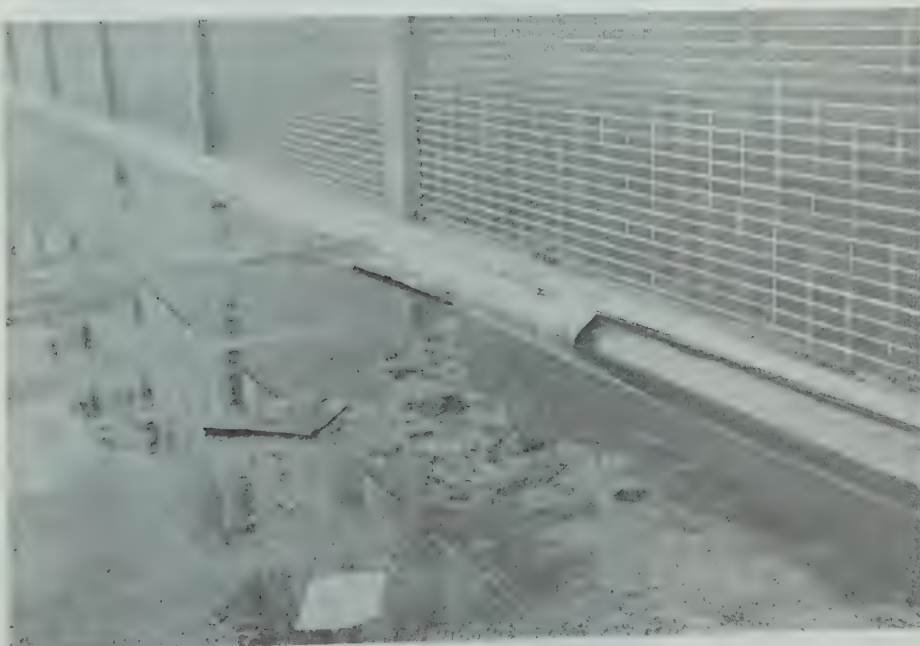
152. Flashings were blown loose, and are now being removed and repaired. The cap flashing was simply crimped and set into brick mortar joint. Flashings sloped toward wall.

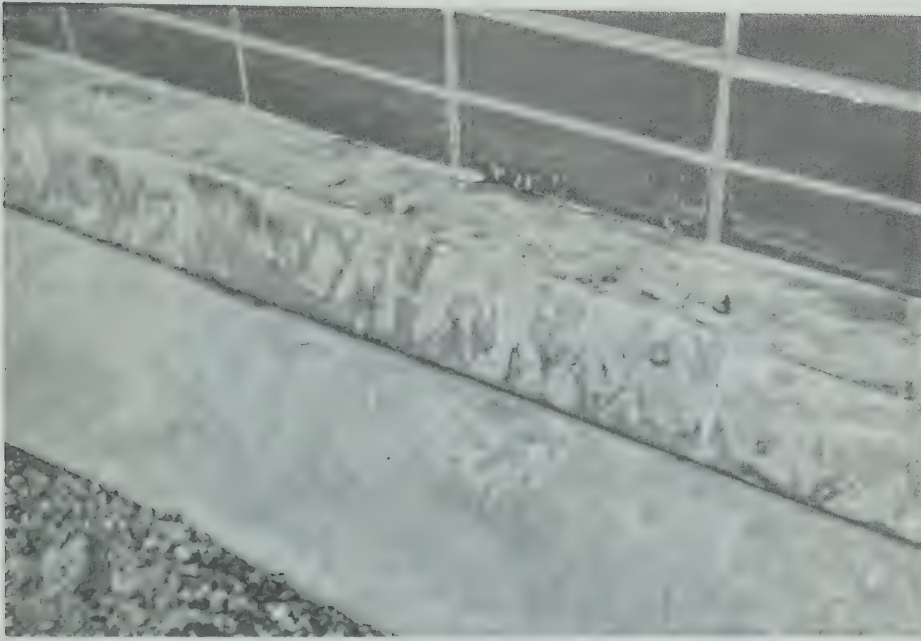
153. Close-up of photo #152. Note severely corroded copper. Mortar "caulking" is loose. Water stain on brick indicates water has been long standing on the cap flashing.
